**Seismic Vulnerability of Masonry Facades  
in Texas and Oklahoma Regions**

**Thesis**

The University of Texas at Austin

**August 2018**

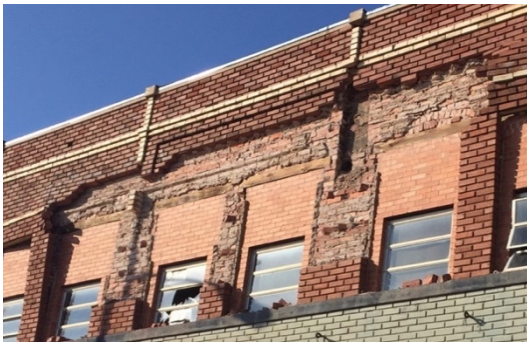
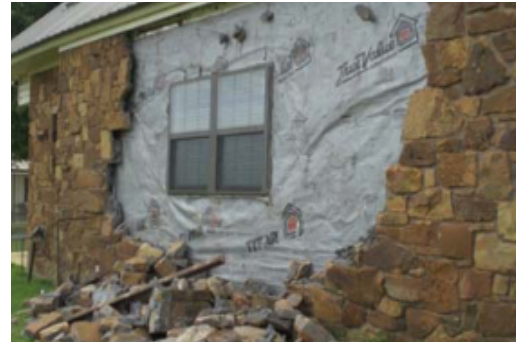
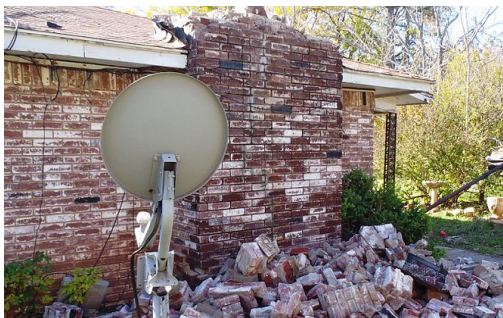
Figure 1.1. Damage to masonry buildings due to Oklahoma earthquakes: (a) M5.0 Cushing, (b) M5.8 Pawnee, and (c) M5.7 Prague. (EERI, 2016)

Much of the observed damage following the 2011 M5.7 Prague, OK, the 2016 M5.8 Pawnee, OK, and the 2016 M5.0 Cushing, OK earthquakes includes masonry veneer and chimney failures in residential homes, which has generated millions of dollars of insurance claims. Insurance companies paid \$5.1 million on earthquake claims in Oklahoma from 2010 through 2016, but that was only with an approval rating of approximately 3 in 20 claims, according to Tulsa World News. Following the M5.8 Pawnee event, 423 insurance claims were filed for just that particular earthquake. (Jones, 2017)

While the typical damage is nonstructural, such as in Figure 1.1, having widespread occurrences significantly impact those residing in the region experiencing the increase in seismic activity. Failing brick facades causes not only a physical hazard to residents, but the need for repairs becomes costly for both individuals and governmental infrastructure organizations. According to the one-year USGS (2016a) earthquake hazard predictions accounting for induced seismic activity, the likelihood of experiencing minor damage from an earthquake in parts of the Central U.S., such as Oklahoma, is now comparable with that in California, as shown in Figure 1.2.

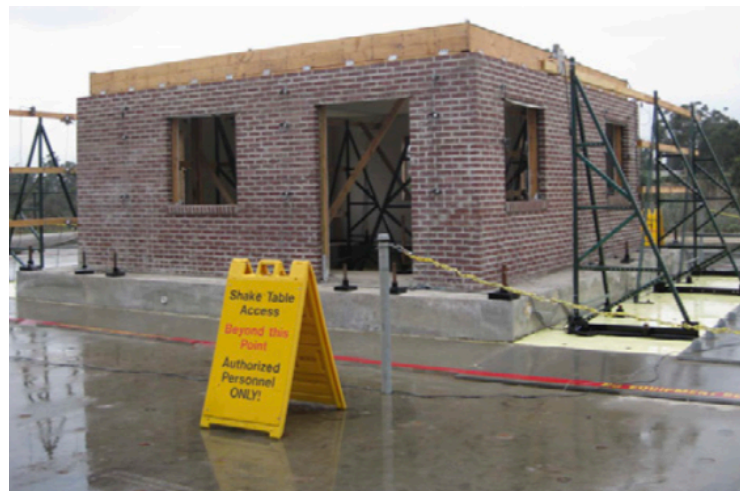
Figure 1.10. Setup of shake table wood-framed specimen from previous Klingner et al. study at UCSD. (Klingner et al., 2013)

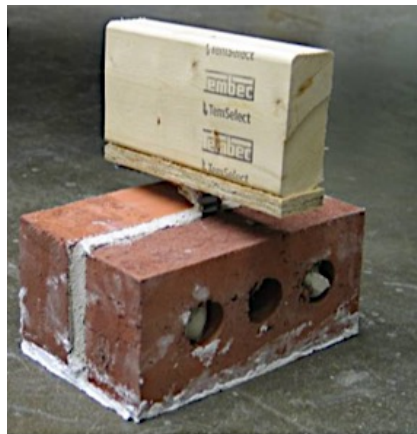
Figure 2.3. Tie subassembly test setup. (Reneckis, 2009)

In order to experimentally determine the cyclic behavior of a certain type of brick veneer tie, Choi and Reneckis (2004) created experimental subassemblies, shown in Figure 2.3, out of the exact same materials used to build the full-scale wall specimens. Approximately 210 subassemblies were tested by monotonic and cyclic out-of-plane loading. The goal was to evaluate the stiffness, strength, and failure mode of the mortar-tie-fastener system itself, rather than just a single tie without any attachment. Reneckis and LaFave (2009) proposed uniaxial hysteretic models to simulate tie behavior, based on these tests. These hysteretic models served as the basis of the current study, with some modifications, as will be discussed in the following sections.

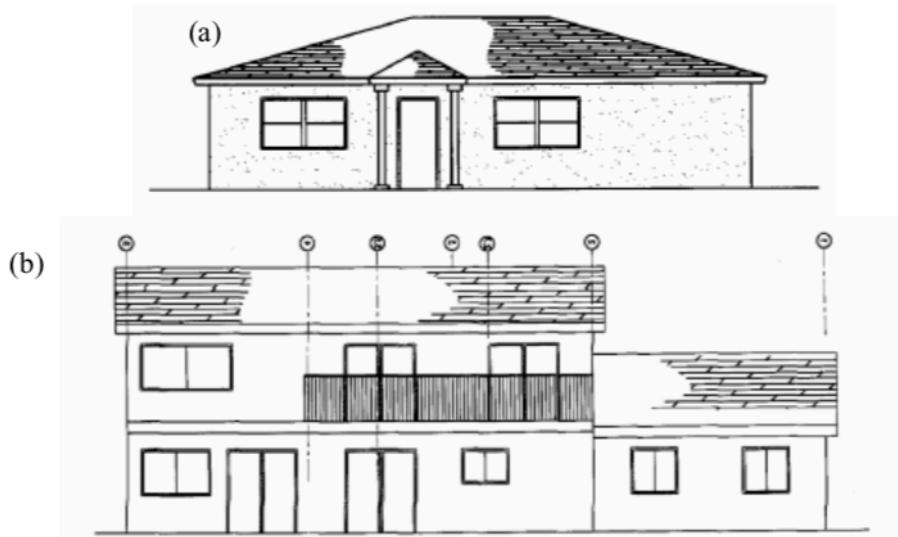
Figure 3.2 Representative elevations of model prototype houses for: (a) one story and (b) two stories. (Isoda et al. 2001) (Schematic from Reneckis and LaFave, 2009)
